#### Subject: Nuclear Metals, Inc. Site, Concord, MA Groundwater Non-Time-Critical Removal Action Revised Construction Completion and Final Report

# NUCLEAR METALS, INC. SUPERFUND SITE CONCORD, MASSACHUSETTS

# Groundwater Non-Time-Critical Removal Action Construction Completion and Final Report

## Appendix B Treatment System Process Flow Diagram and Lay Out

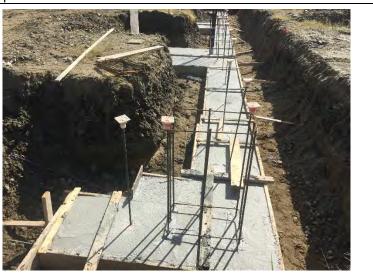
View of foundation with rebar

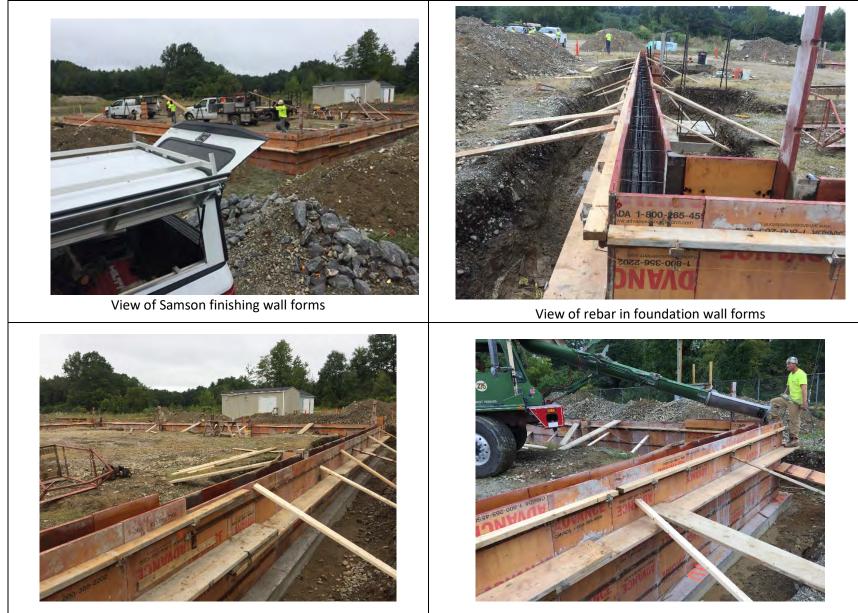
Final View of foundation wall forms

View of concrete being poured into foundation wall forms

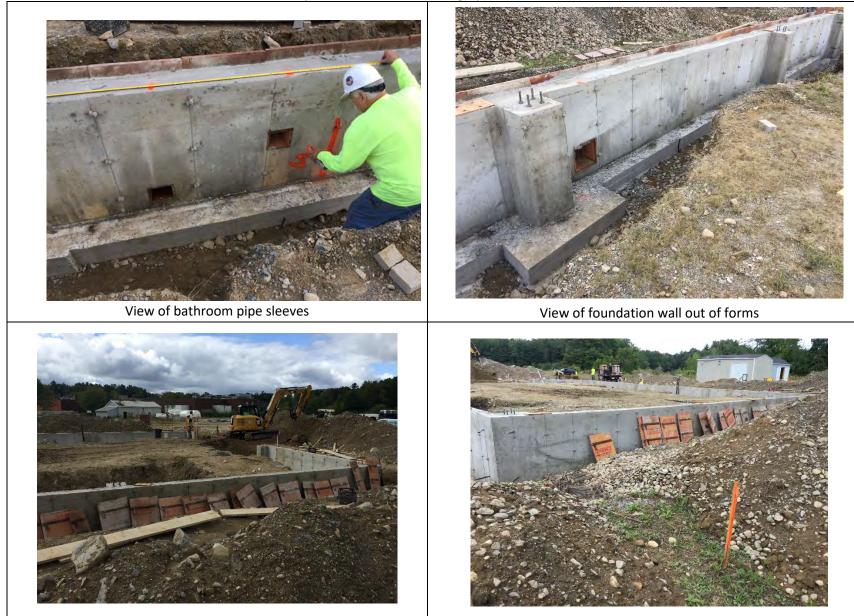
View of Nashoba digging final section of foundation

View of Complete foundation without forms

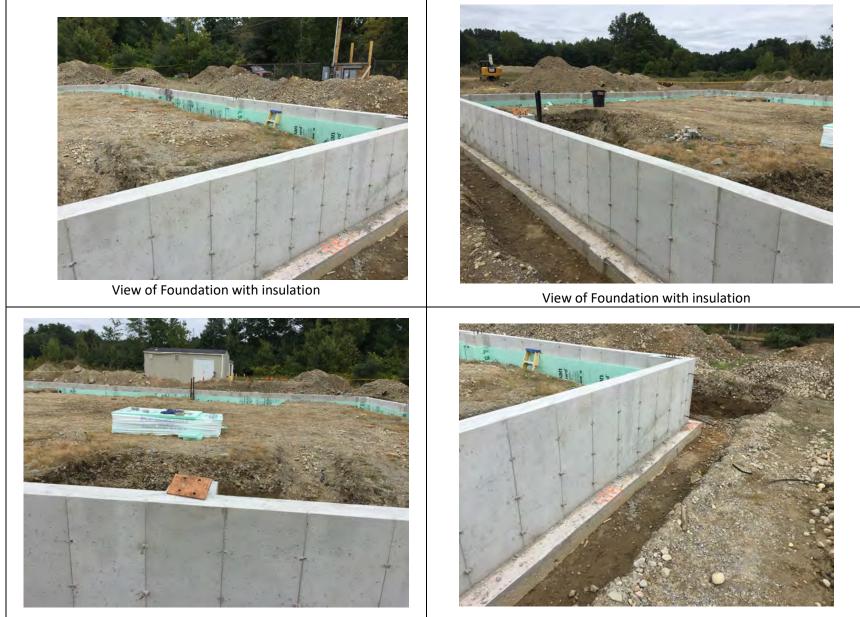
View of Foundation with insulation

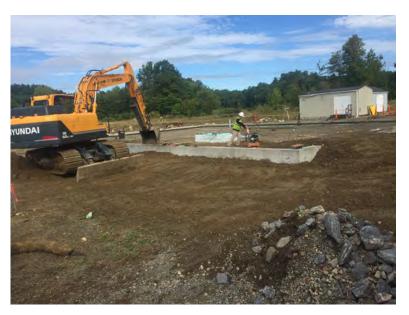
View of Nashoba backfilling and compacting around foundation

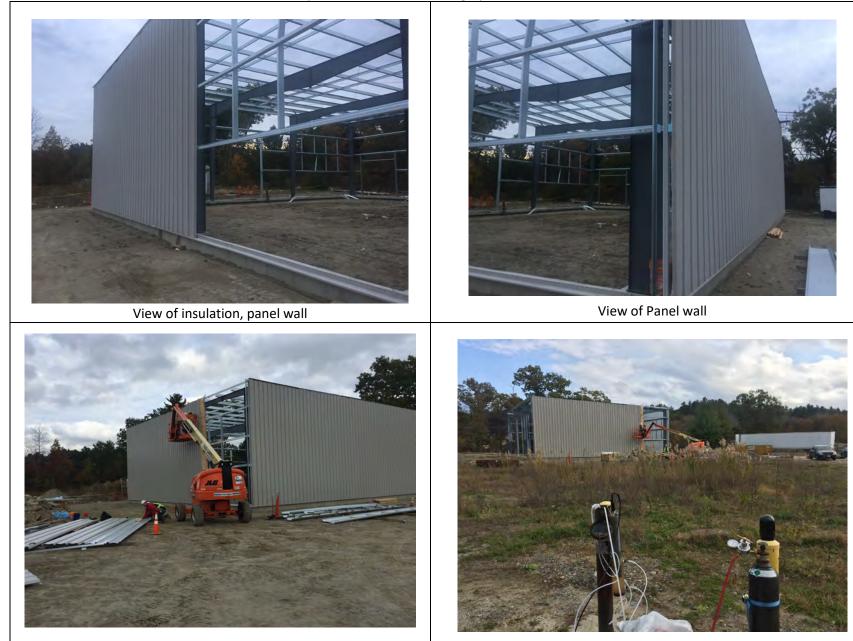
View of insulation/panels being placed

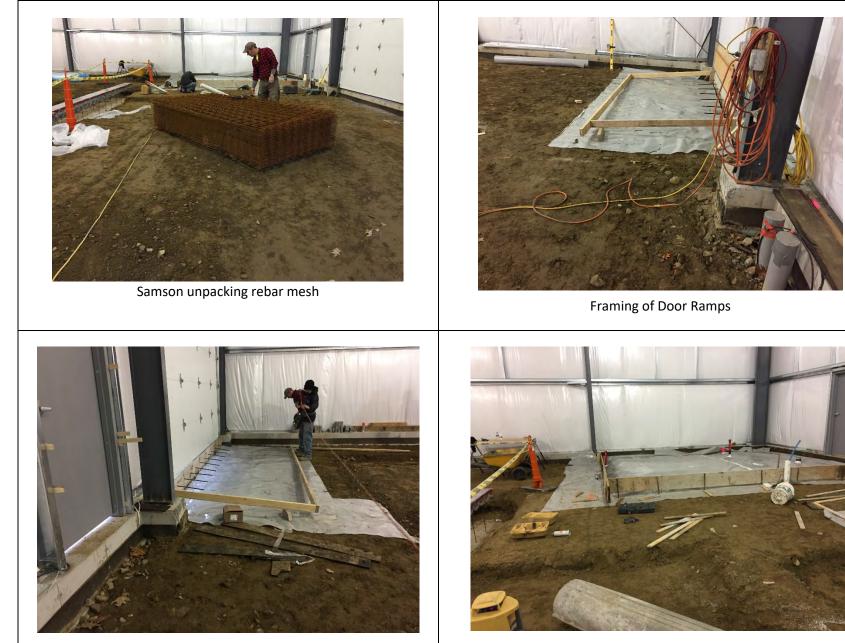
Framing of Door Ramps

Framing of Office foundation

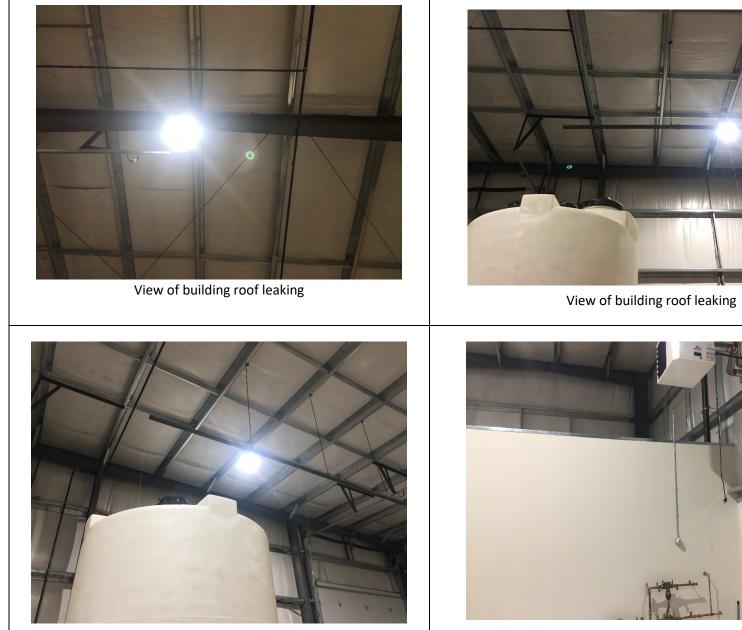
View of building roof leaking

Building foundation work started in September 2018. The steel frame was completed in early October, along with most of the walls and potable water service to the building. Wall panels, insulation, the roof, and overhead and man-doors were completed in November. The slab concrete work was completed in December, along with build out of the office and bathroom, and rough electrical and plumbing. Propane service and split heaters were installed in January 2019. Final electrical and plumbing was completed in January 2019. In May 2019, the roof panels were replaced, at cost of the building vendor, due to improper installation during the initial building fabrication. Eversource provided the power service to the building in February 2019. The building sub-contractor replaced the roof and one access ramp under warranty in April 2019.
